## Malmesbury Market Cross

Malmesbury's Market Cross stands in the centre of the town at the north end of the High Street and south west of adjacent Malmesbury Abbey. It has been used as shelter from the elements by generations, it has been painted by countless artists including Turner and it has been damaged by trucks and bin lorries. Unusually there has been little detailed research around such an important structure. This paper aims to bring together the different sources of information on the Market Cross, it will examine its architecture and iconography, its history and links to the Abbey and investigate other similar structures in England. Through the range of sources the aim is to better understand key questions such as when was it built, who paid for its construction and how has it survived?

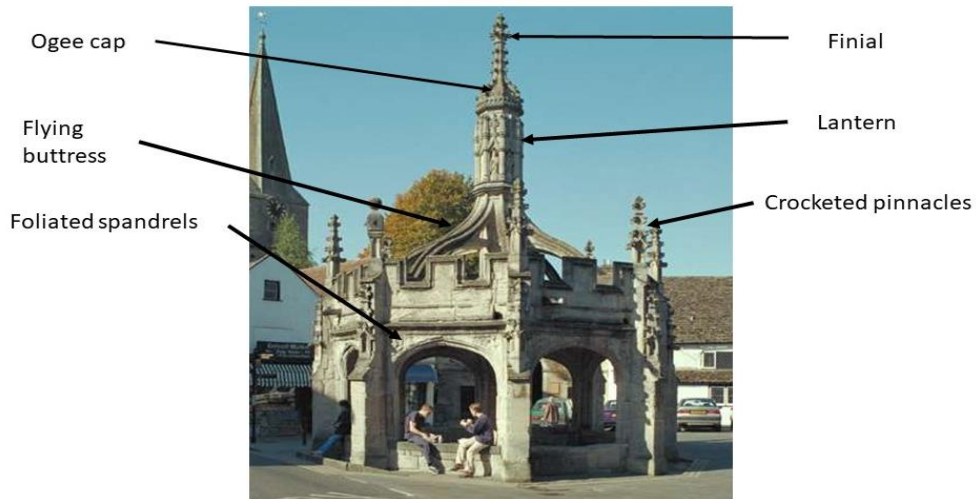
This style of architecture is known as Perpendicular characterised by pronounced verticals, tracery and complex van vaults. Architectural elements from the listing are shown below.

Image Historic England 2020

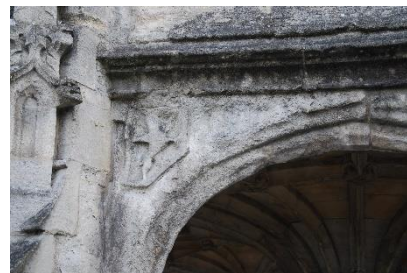
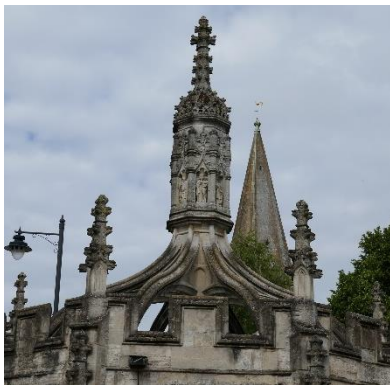
Foliate spandrels - a triangular space between the top of an arch filled with decorative leaf carving.

Flying buttresses - masonry structure typically consisting of an inclined bar carried on a half arch that extends ("flies") from the upper part of a wall to a pier some distance away and carries the thrust of a roof or vault (Britannia 2020).  
Cyma moulded is moulding of double curvature

Crocketed pinnacles - A crocket is a stylized carving of curled leaves, buds or flowers used at regular intervals to decorate the sloping edges of a pinnacle (vertical ornament of pyramidal or conical shape).

Lantern - small cupola-like structure, usually with decorative arcades, mounted on top of a dome.

Finials - decorative upper termination of a pinnacle, gable end, buttress, canopy, or spire. It usually consists of a vertical, pointed central element surrounded by four out-curving leaves or scrolls. (Britannia 2020).

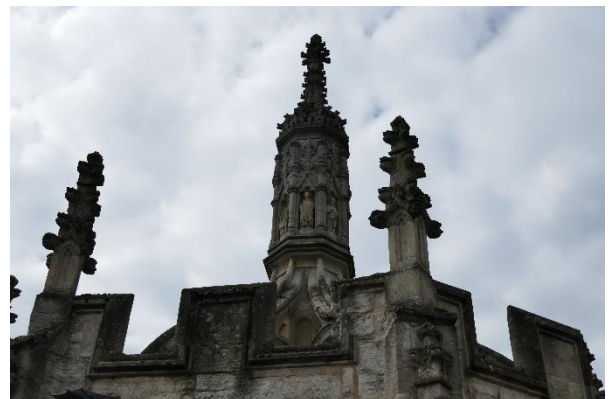
Ogee cap a decorative line formed by two connected curves

Octagonal shaft – a supporting eight-sided column

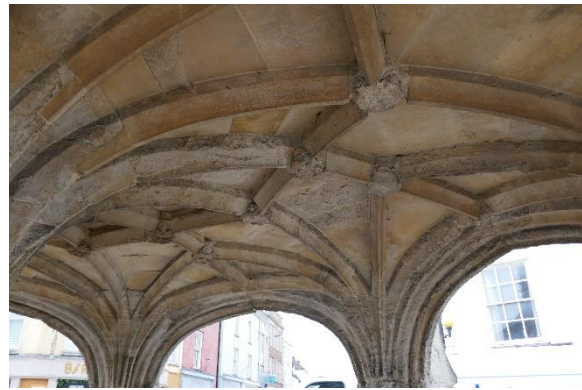
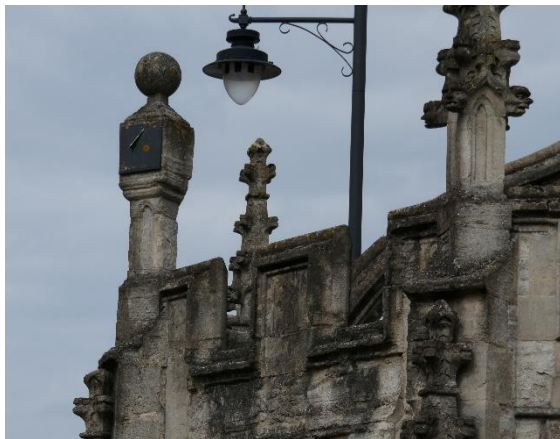
The south east pinnacle differs from the other, it is topped by a sun dial and ball finial. The sun dial has Roman numerals with the SE face covering 5am – 2pm and the SW face 8am to 7pm. It is made from slate and brass and is believed to date from the 16<sup>th</sup> century. (Sun Dial Society 2021).

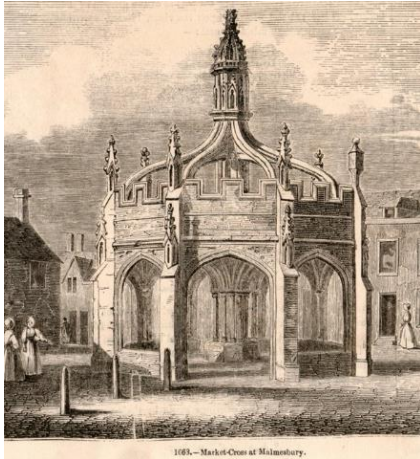
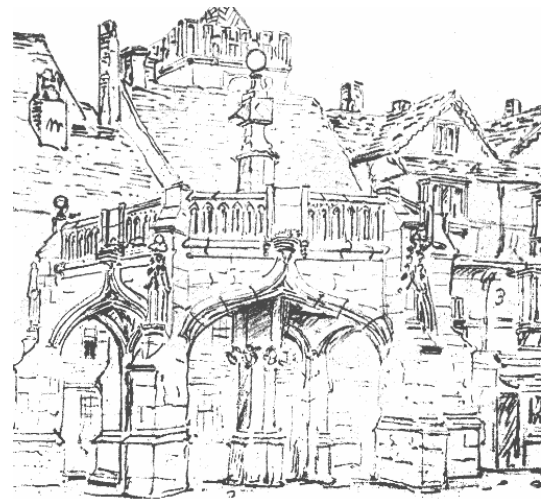
The earliest engraving of the market cross dating from c. 1683 shows the ball finial in place. It is also interesting that the top of the Salisbury Market cross, before restoration had a very similar arrangement.

Salisbury Poultry Cross (Vallance 1920)

Malmesbury Market Cross 1683 (Malmesbury Civic Trust)

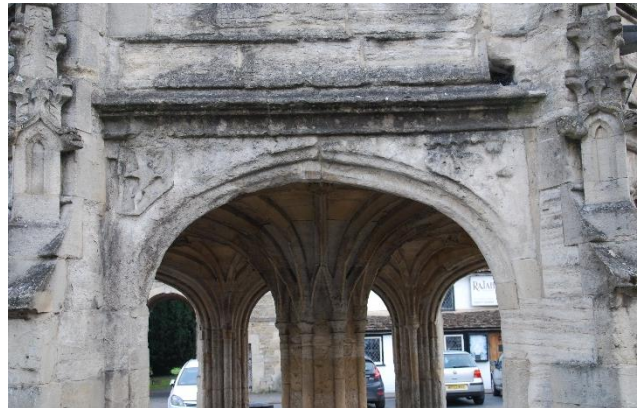
John Bowen's book in 2000 provides images of two carvings in the south east spandrel. The Gryphon which is just visible today is part of the arms of the Mitred Abbott of Malmesbury, the second much more weathered shows a crowned cross surmounting an orb, the arms of King Athelstan, used by the Old Corporation up until 1615. It is also familiar as the Malmesbury coat of arms today.

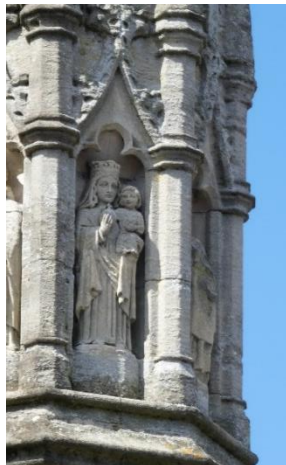
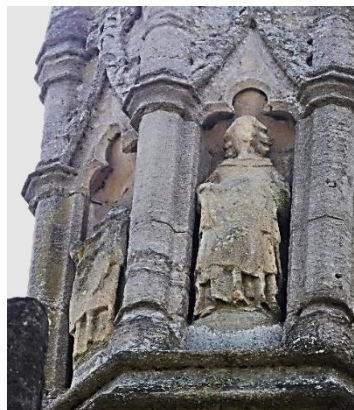
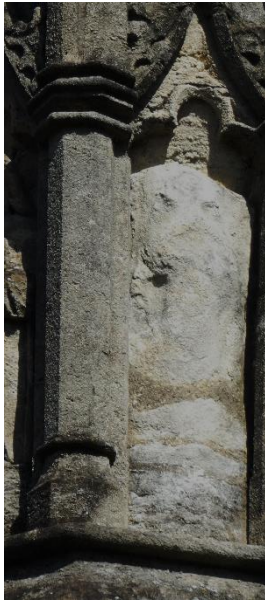
From left to right and starting with the statue facing north-east, The Virgin, St. Aldhelm, St. Lawrence, St. Peter, The Rood and St. Paul.

A Local Benefactress which is heavily eroded and King Athelstan the final statue.

The Rood faces the Abbey and King Athelstan the town. Saints Peter, Paul and Lawrence reflect the dedication of the early churches of Malmesbury Abbey. The statues show a mix of ecclesiastical and secular imagery which support the images in the spandrels.

figures in bas relief. These include: On the north, Madonna and Child; north-west, Bishop St. Aldhelm; west, Deacon St. Lawrence; south-west, St. Peter; south, the Rood; south-east, St. Paul; east, figure of a lady supposed to have been a local benefactress; north-east, King Athelstan. In the restoration care has been taken to preserve the original architecture and outline of the building.

Similarly reported “beautifully carved figures which occupy the canopied niches of the central turret, all those formally missing having been faithfully reproduced: North niche, Madonna and Child; north-west, St. Aldhelm (Bishop); west, St. Lawrence (Deacon); south-west, St. Peter; south niche, the Rood; south-east niche, St. Paul; east niche, a lady without emblem (supposed to be a benefactress); north-east niche, King Athelstan.”

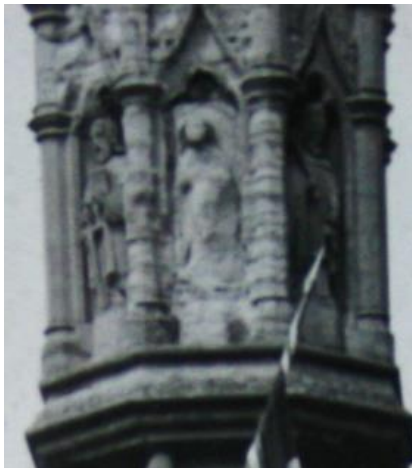
Malmesbury Civic Trust

The eroded statue of the Local Benefactress could be an important clue to who funded the build of the Market Cross. No further information has been found as to her identity but the image left shows what she looked like in 1937. Her dress appears medieval rather than Victorian but that is not unusual in Victorian art.

Statues are shown in the earliest engraving of the market cross and given the design of the lantern, there is no reason to believe that they are later additions to the 15<sup>th</sup> century build. It has not been possible to date the statues seen today. In 1881 the pinnacle had “traces of sculptured figures” (WANHS 1881) and again by 1909 the local paper reported that of the statues “only St. Lawrence and a mitred bishop can be made out” and that the cross was dilapidated. So today’s statues are likely to date from the 20<sup>th</sup> century which seems to fit stylistically.

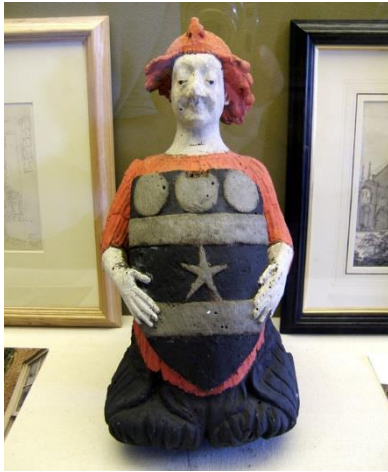
The statue shown left is in the Athelstan Museum. It is described as “*carving, figure of a man holding a shield, a mullet denoting a third son of the Hungerfords, from Malmesbury Abbey, Malmesbury, Wiltshire, 15 cen ?*”

*The shield carries the arms of the Hungerford family, differenced by having a 'mullet' [the five pointed star] in the centre, indicating a third son. This probably refers to Sir Edmund or Edward Hungerford of Down Ampney, d.1484, third son of Sir Walter Hungerford, the first Lord Hungerford”*

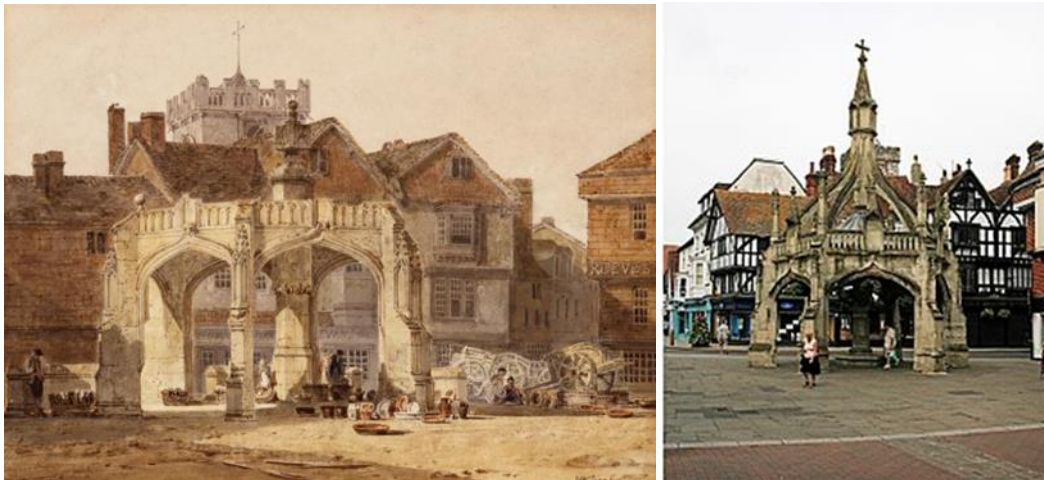
It is described as a hexagonal open arched shelter with buttressed piers enriched with carved and panelled pinnacles. It has a central stone shaft with a stone seat round at the base, carried up through a lead roof and was originally finished with a sundial block. The cross also was originally surrounded by a square of stone seats. So far very similar to Malmesbury and Aubrey's description. However the Poultry Cross underwent significant restoration in the 1850s with the addition of a series of flying buttresses meeting in the centre, covering the sundial and topping the cross with a hexagonal block with a niche on each face, crowned with a pinnacle and cross. The stone seats round the base have also been removed.

The difference can be seen by comparing the drawing by Turner c.1800 and the present day cross.

Images Uart and Wikipedia

There is no sign of the Hungerford crest mentioned by Aubrey in either image.

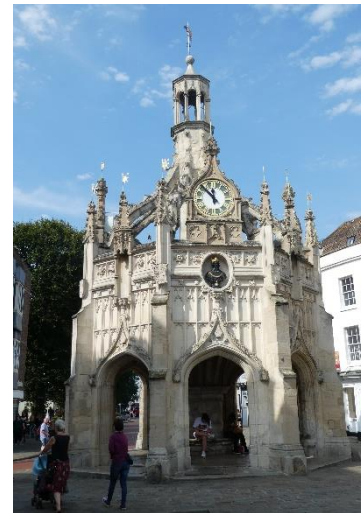
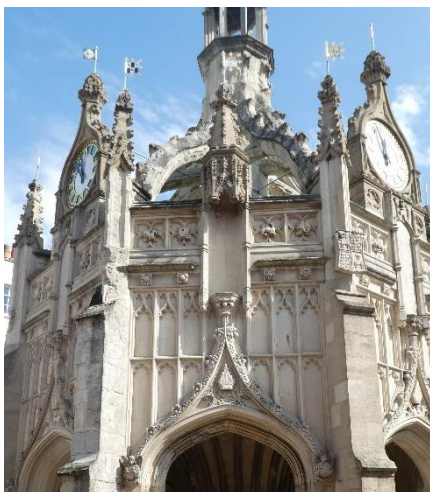
Like Malmesbury it is a vaulted octagonal building with an open arcade. It has 8 buttress piers at the angles which serve to sustain a super incumbent wall, over eight arches, and adorned with panelling, rosettes, shields with armorial bearings, an embattled parapet and pinnacles. The stonework converges from the top of each buttress to the centre, where the eight unite and continue to an apex. The belfry and clock were added in 1724. (Historic England 2020). The Market Cross underwent alteration and restoration in 1746 and in the late 20th century. It is thought to have originally stood in a large market square but this has now been encroached upon by buildings.

The armorial shields albeit restored are still in place at the top of each buttress and there is further iconography in the frieze of the parapet, this may give some indication of where the Hungerford arms of the Malmesbury market cross may have been.

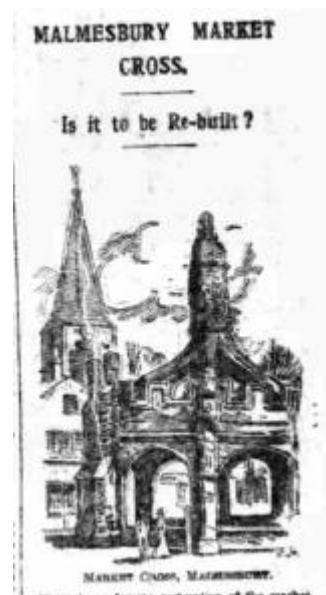
The cost had been c. £700 which alongside the cost of the Abbey restoration had been a major problem but Joe Moore had overcome this by raising subscription. A list of subscribers is included in appendix 2 and includes many familiar names. The structure had been underpinned, new pinnacles and columns provided, a new lead roof and guttering installed and niches filled with restored figures in bas relief. Importantly “care has been taken to preserve the original architecture and outline of the building. The statues are also listed as

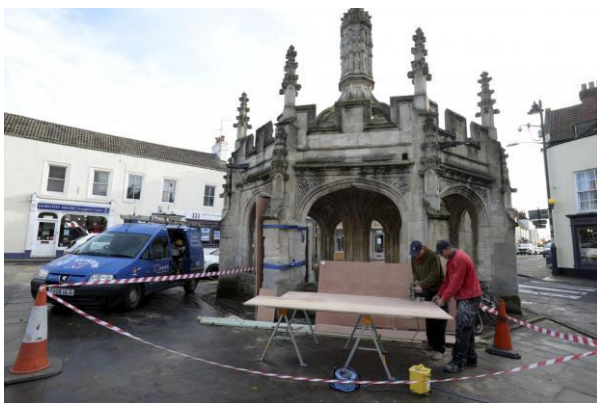
Wilts. and Glouc. Standard 2018

The threat is ever present, in November 2018 there was severe damage caused by a recycling lorry, thankfully now fully repaired.

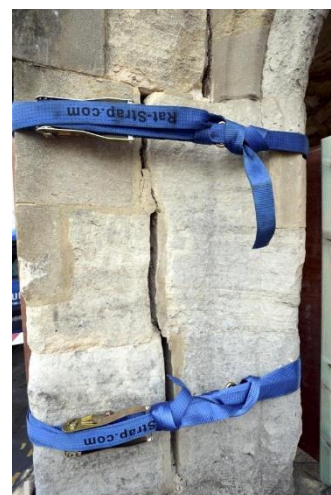
Details of the work carried out c1800, 1883, 1950 and even 1990-1 are missing. However the specification for the 1910 repair is held in Wiltshire and Swindon History Centre.

Details of the work to be carried out match that reported in the press. Only absolutely perished stones were to be renewed and the repairs were to be in the best Box stone. The lower part of the finial was to remain but the upper part and terminal were to be entirely new. Oddly there was no mention at all of the statues. The new stone is clearly shown in the image to the right (Malmesbury Civic Trust).

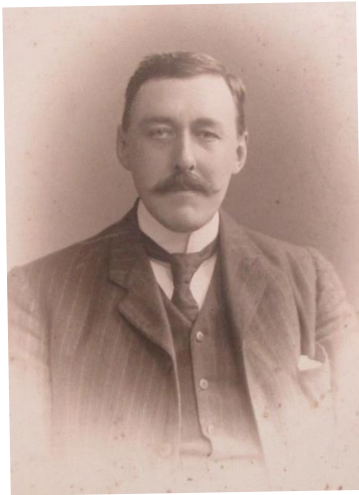
Harold Brakspear saviour of the market cross in 1910 and Specification of Works No.125 detailing repairs to be carried out. Both courtesy of Wiltshire and Swindon History Centre.
